MARYLAND PROFESSIONAL MOLD SERVICES LLC
POST OFFICE BOX 613
PASADENA, MARYLAND 21123-0613

Observations during the visual moisture and mold investigation

On Tuesday, March 16 , 2010, we were contracted to re-investigate concerns about water intrusion at:

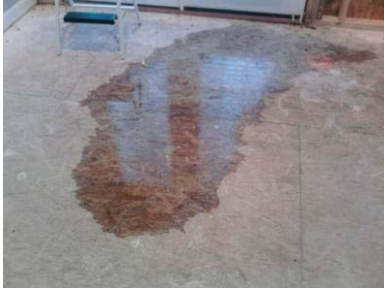
Over this past weekend she observed water intrusion in multiple locations around the office bedroom exterior door.

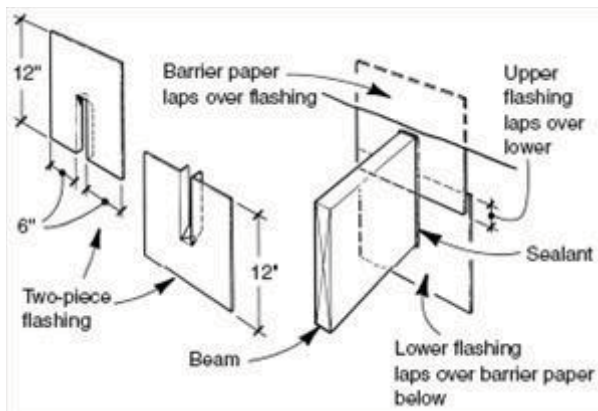
Cantilevered Joists/Beams

Cantilevered deck or balcony joists that project through the wall framing are trouble spots. Protect them with a two-part flashing sealed with urethane. The top flashing piece must overlap the bottom one.

In the figure above a depiction of flashing a cantilevered joist is seen, when observing the flashing on the decks in this neighborhood, it is impossible to determine how this flashing was achieved.

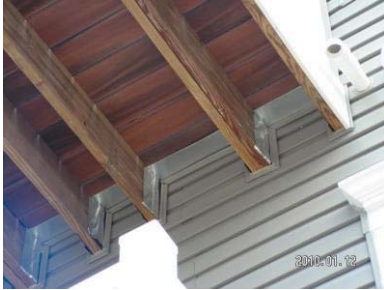
When observing the repaired and retrofit flashed deck, directly above the water intrusion area, one can see the use of additional flashing and, I assume, exterior rated aluminum tape.

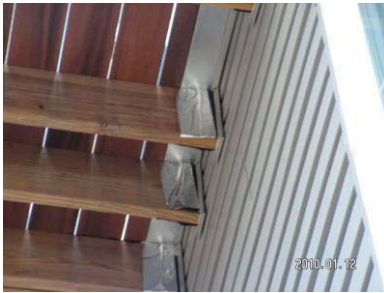
If you observe closely, or simply zoom in on this shot, one can see open areas that remain.

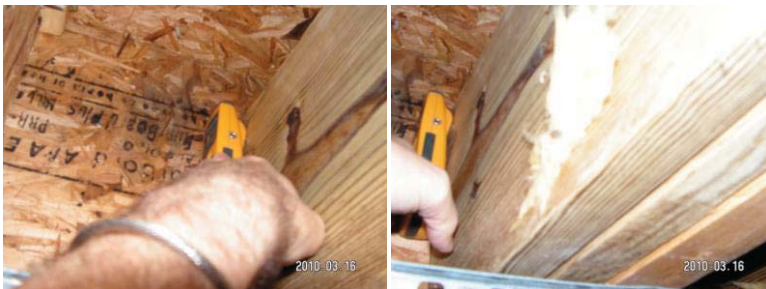
During our inspection on March 17, we did find elevated areas of moisture along two of the cantilevered joists.

This area of elevated moisture is directly in conjunction with the aforementioned concerns about openings to the outside. With the lights turned off in the room, we can see the sun.

This area of moisture intrusion did not contribute to the puddle of water seen on the floor previously in this report; however, could certainly become a problem if this area is not addressed and then finished with organic building materials.

During our previous inspection we recommended that foam insulation be applied along the open penetrations, this was done on one joist and should be done on all the joists since this area was responsible for the major water intrusion and mold problem last year.

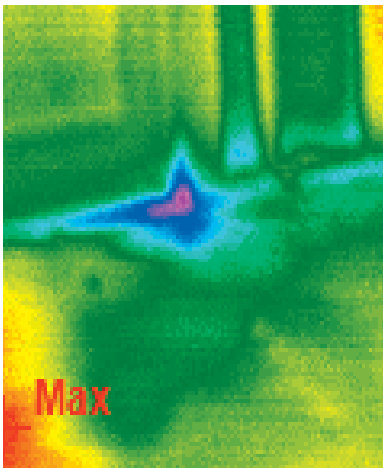
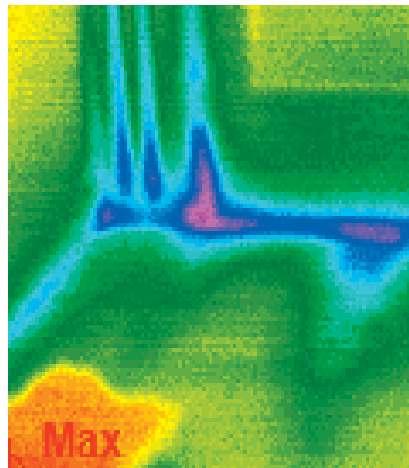
As you can see by the thermal images below, water intrusion occurred in two locations, one on each door.

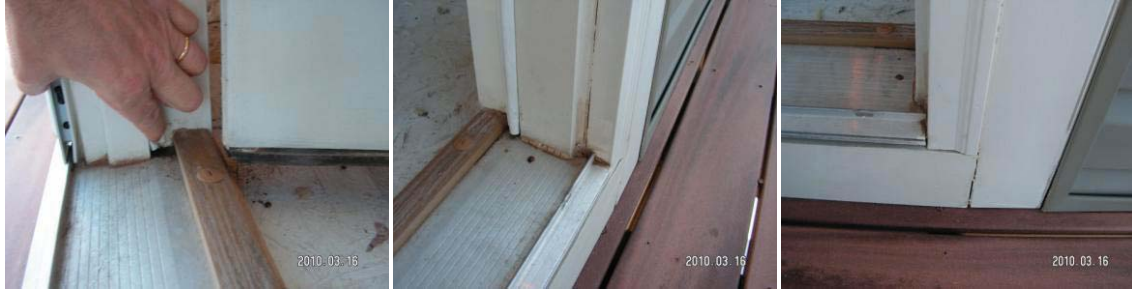
Let's start with the functional door, the weather stripping does not extend all the way to threshold, and the door installation itself does not provide a tight seal.

These situations can generally be addressed with additional caulking as well as adjusting the strike plate to provide a tight seal against the wind driven rain. Sometimes there is a need to install an additional deadbolt, at the top of the door, to provide protection when this door is exposed to open areas and high winds.

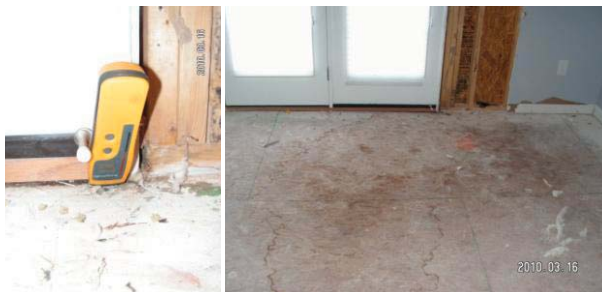
The overwhelming majority of the water intrusion occurred from the stationary door side, from behind the door frame.

It's impossible to determine if the flashing was installed correctly for this French door. When examined from the outside, there are number of openings and opportunities for water to intrude during windy conditions.

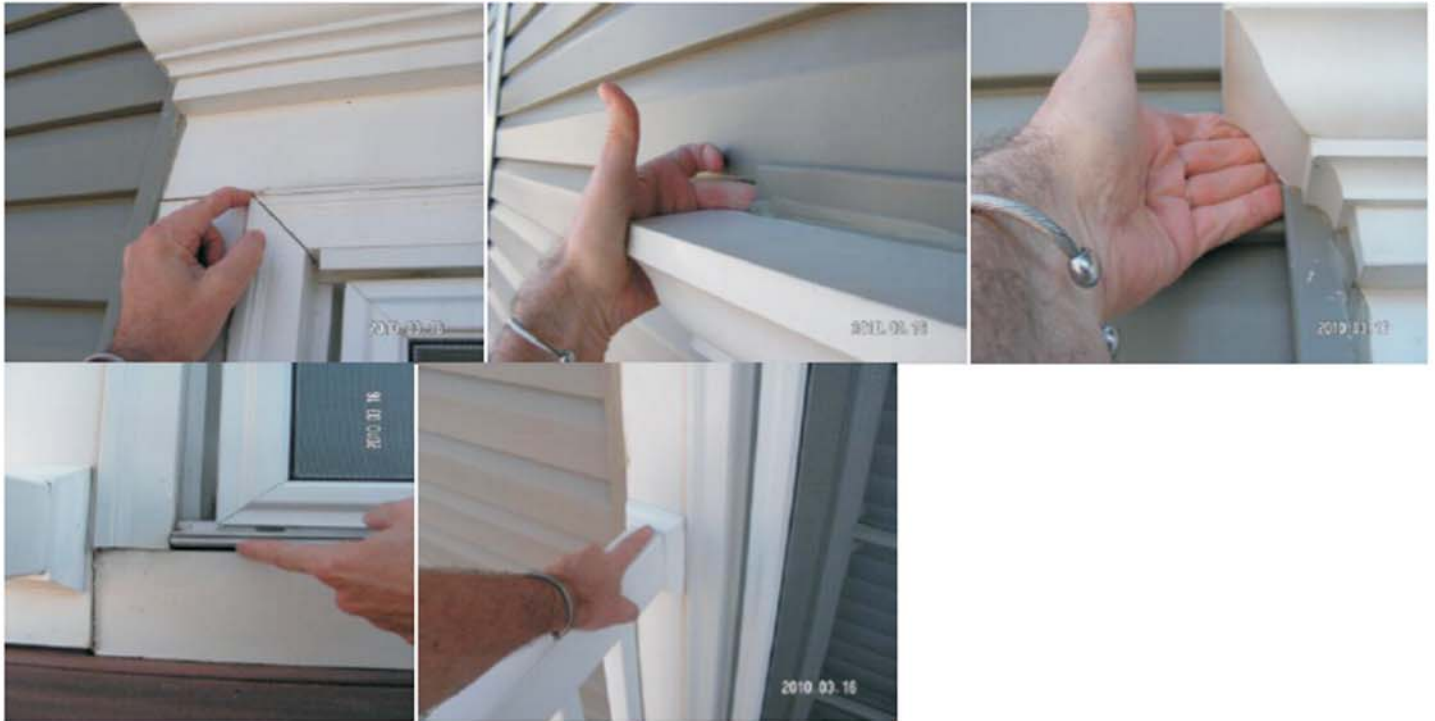
As you can see by the photographs below, any of these openings could allow wind driven rain to enter behind the door flashing.

All of these opportunities should be addressed and then **verified with a high pressure hose test** to determine if the repairs were successful.

The extent of the repair may become clearer once some of the trim is removed and the door flashing verified.

It makes no sense to finish and sheet rock the inside of this unit until we're sure that we've got the water intrusion corrected permanently.
